PB00-910401
NTSB/AAR-00/01
DCA97MA058

AIRCRAFT ACCIDENT REPORT

CONTROLLED FLIGHT INTO TERRAIN
KOREAN AIR FLIGHT 801
BOEING 747-300, HL7468
NIMITZ HILL, GUAM
AUGUST 6, 1997

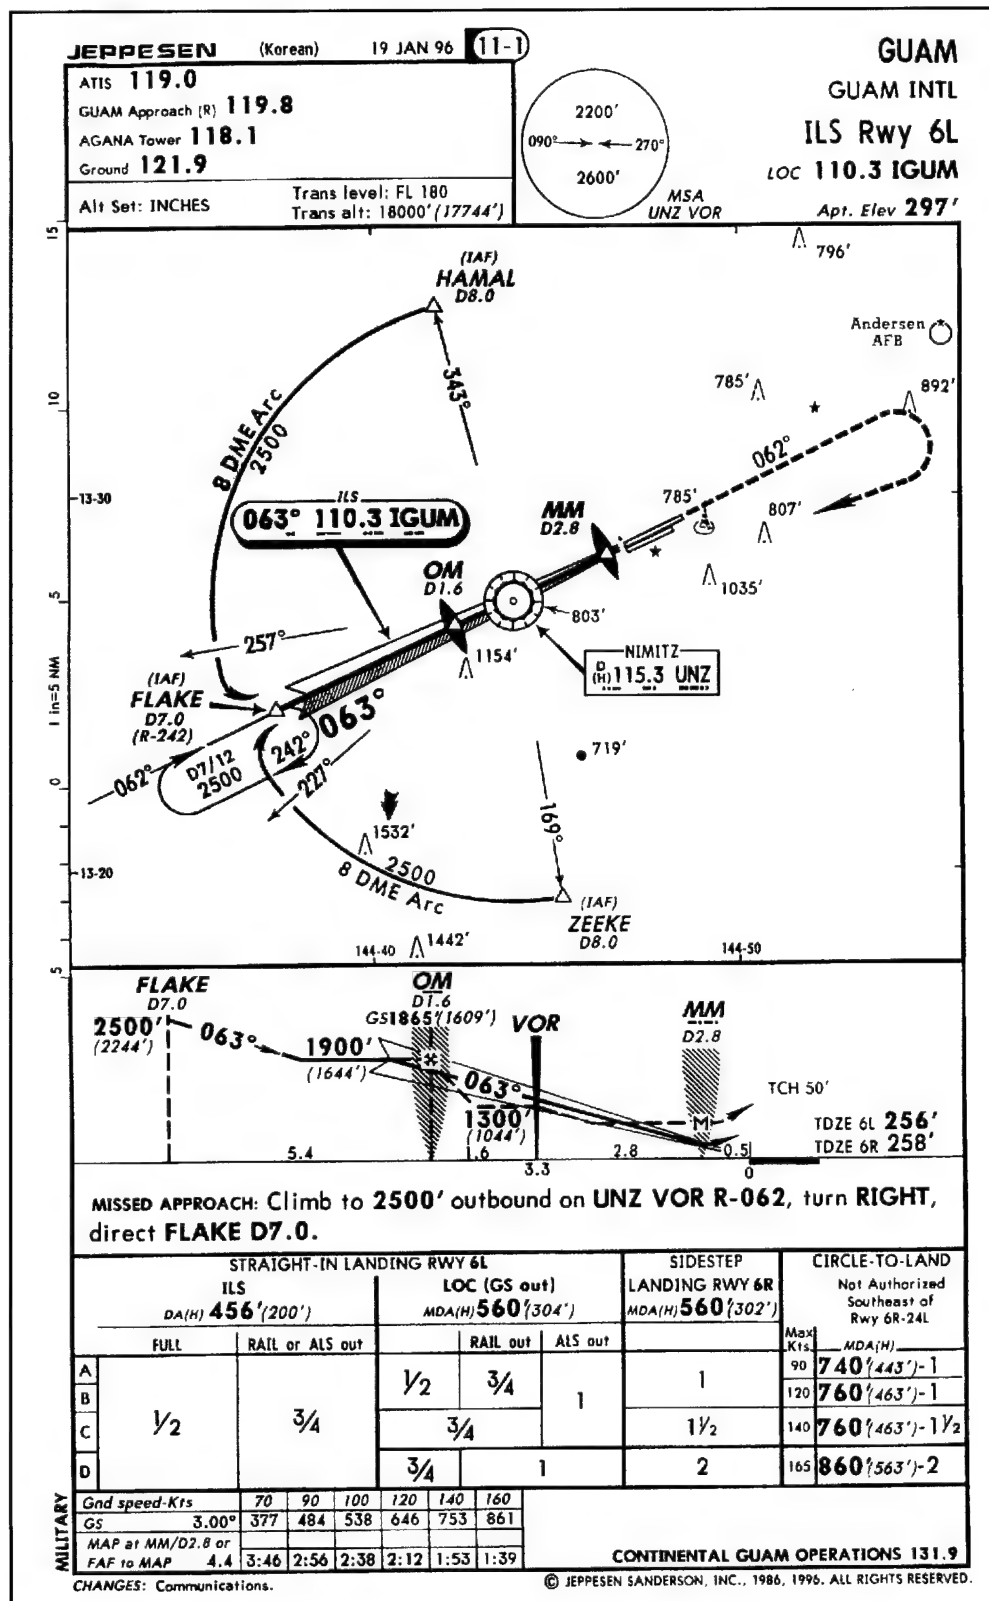
Charts 11-1 and 13-2 were found side by side and were visible through one face of the plastic sleeve. Chart 16-1 and the blank side of an approach plate were visible through the opposite face of the plastic sleeve. Chart 11-1, which is shown in figure 7, had the following items highlighted with a green fluorescent tint:⁶²

Figure 7. The January 19, 1996, 11-1 ILS runway 6L instrument approach chart.

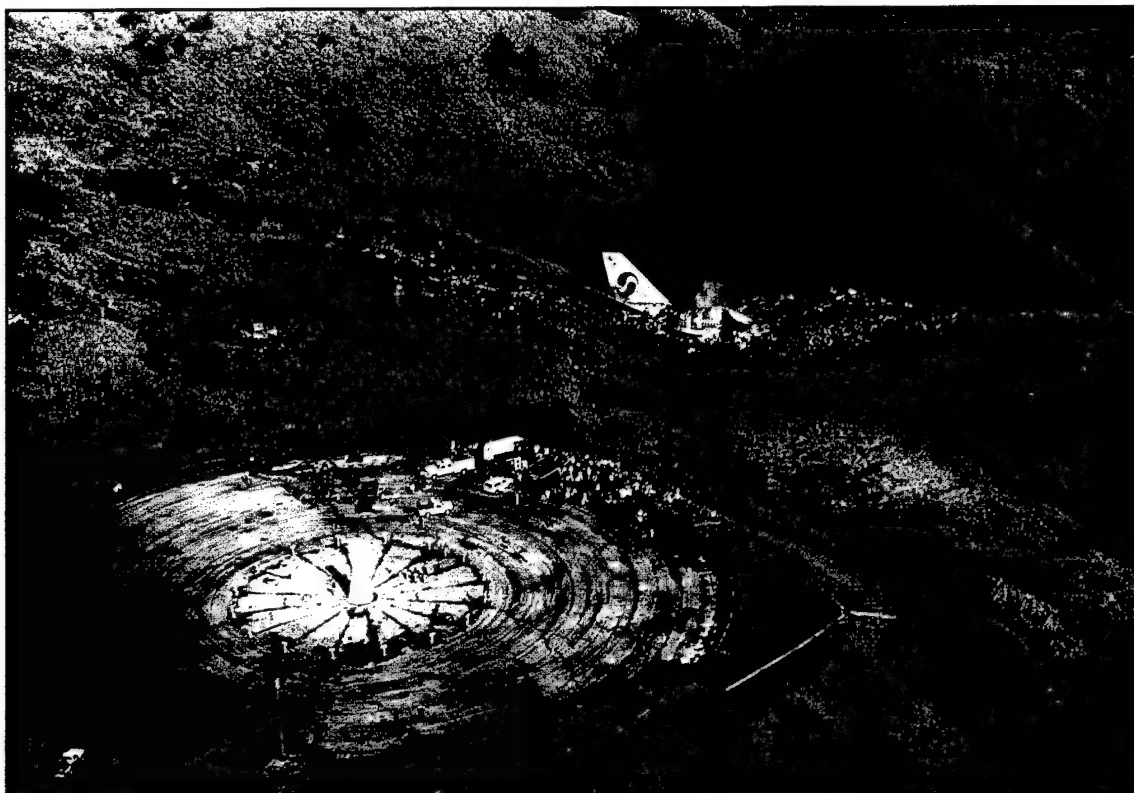
Figure 8b. Closer view of the wreckage from Korean Air flight 801 and the NIMITZ VOR.

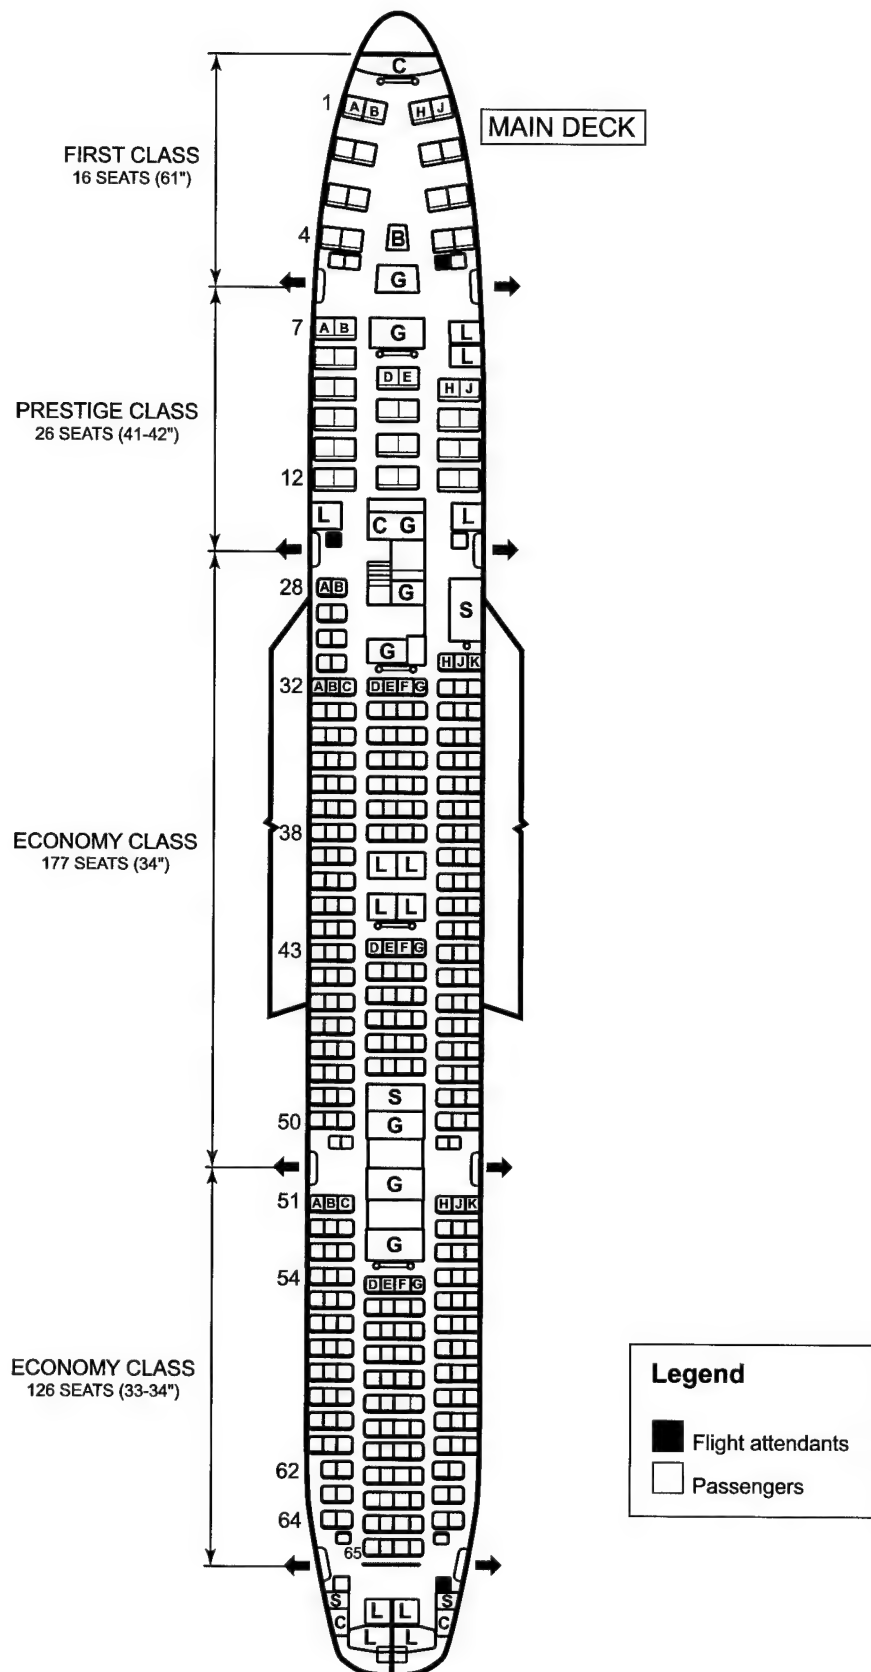
Of the 26 survivors of the accident, 7 passengers and 1 flight attendant were seated in the first class section, 1 flight attendant was seated in the prestige class section, 7 passengers were seated in the forward economy class section, and 9 passengers and 1 flight attendant were seated in the aft economy class section. Two of the surviving flight attendants and 13 of the surviving passengers were seated on the right side of the airplane; 6 of these 13 passengers were seated over the right wing. Figure 9 shows the 747-300 cabin configuration and the survivor seat locations.

Figure 9. Korean Air flight 801 cabin configuration and survivor seat locations.
